**PAPER 10:
LANDSLIDES IN THE HILLSIDE DEVELOPMENT IN THE HULU KLANG,
KLANG VALLEY**

This paper has been written to study on rapid landslide occurrence at the hillside development areas, in the Hulu Kelang. Being an urban area and highly populated, the impacts of these tragedies are detrimental to humans and properties. From literature, it is found that less action were taken by the architects to learn from the mistakes. From the landslides investigations reports, it is shown that landslides were caused mainly by failures of the retaining wall and other combinations factor like lack of maintenance, less coordination during construction stage and design problem. The question is what are architect's roles and contributions in reducing landslides in hillside development in Malaysia. The discussion will be on landslides: the causal factors, the impacts, mitigation actions and architectural aspects to be considered in designing the site plan. The site plan design that has been practiced on the hillside development area in the preview of the landslide tragedies that happened in Hulu Kelang. On the end the architect shall be aware of their roles and apprehend good design practice for hil

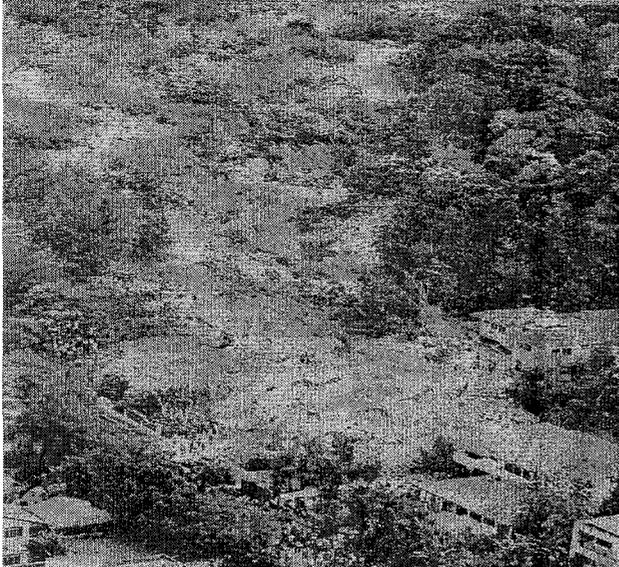
Figure 5.6: Debris flow fall and ruined the bungalow in hill view development

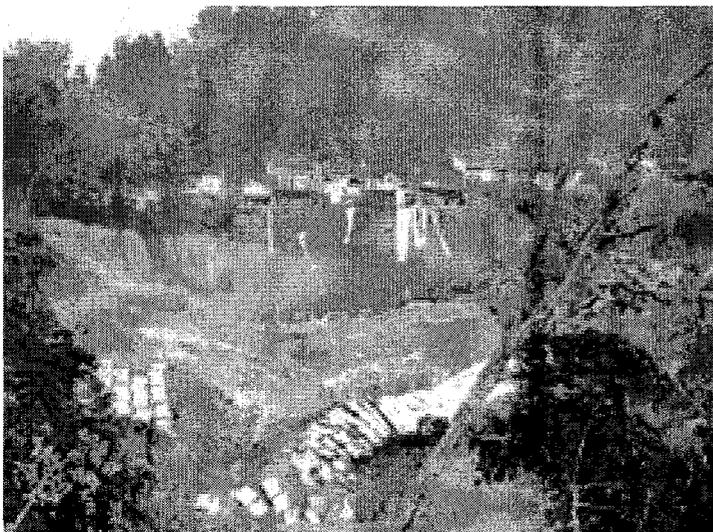
Figure 5.8: Retaining wall failed in zoo view development, it flow to kampong pasir area and ruined 3 blocks of long house

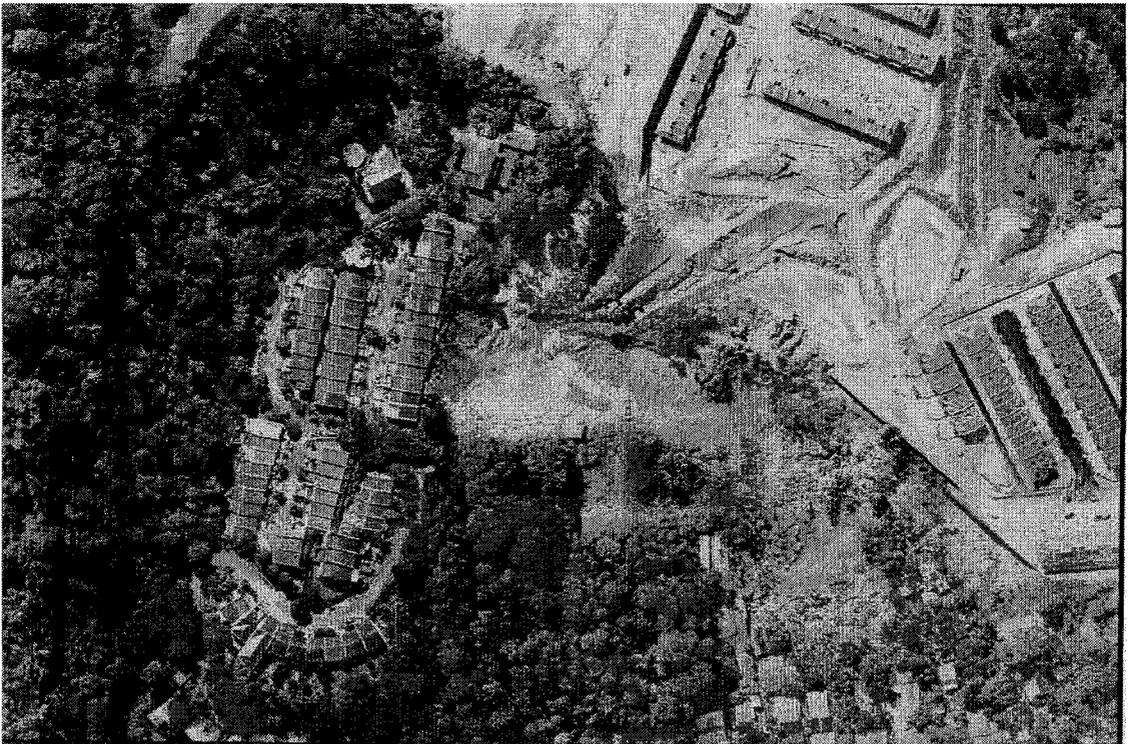
Figure 5.9 : Zoo view – kampong pasir landslides looking from aerial view
